Manhole Inspection Summary

Manhole # S29I__012MH

Location Address: **W Pratt**

Cross Street: **MLK**

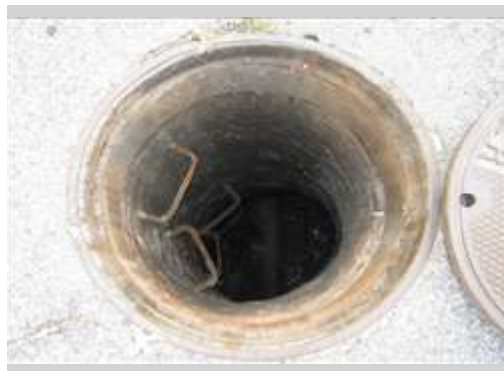
Frame View

Condition: ☐ Sound ☐ Cracked ☒ **Leaks**

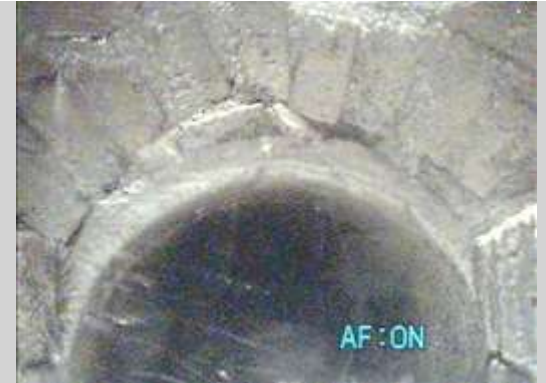
12 O'Clock Outflow

Pipe Height: **10.8** (in.) Rod and Bar (Angled)
Pipe Material: **Clay** ☐ Pipe Lined
Invert Depth: **14.80** (ft.) Flow Characteristics: **Fast**
Deposits: ☒ None ☐ Mud ☐ Sludge ☐ Debris ☐ Grease
Silt Depth: **0** (in.) Deposits Extent:
Infiltration: **None** Pipe Seal Cond: **Unknown**

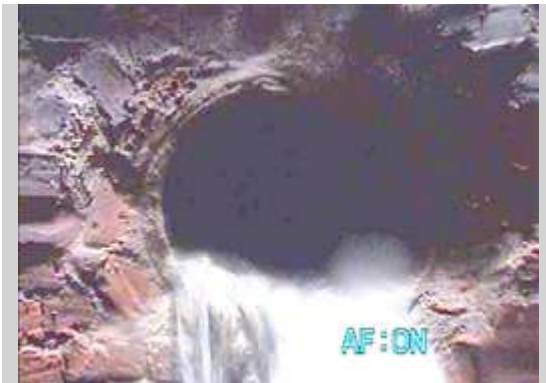
6 O'Clock Inflow

Pipe Height: **10.8** (in.) Rod and Bar (Angled)
Pipe Material: **Clay** ☐ Pipe Lined
Invert Depth: **10.45** (ft.) Flow Characteristics: **Fast**
Deposits: ☒ None ☐ Mud ☐ Sludge ☐ Debris ☐ Grease
Silt Depth: **0** (in.) Deposits Extent:
Infiltration: **None** Pipe Seal Cond: **Unknown**

Drop: **Inside** Rod and Bar
Angled: **Yes** Reading: **13.30** (ft.)
Inv Depth: **14.30** (ft.)
Drop Condition: **Clogged**
